Vibration and Shock tests on a typical Current Transformer Set

NLR-CR-2009-412

This document contains the description and the results of vibration and Shock tests, performed for ELEQ Steenwijk B.V. on a typical current transformer set.

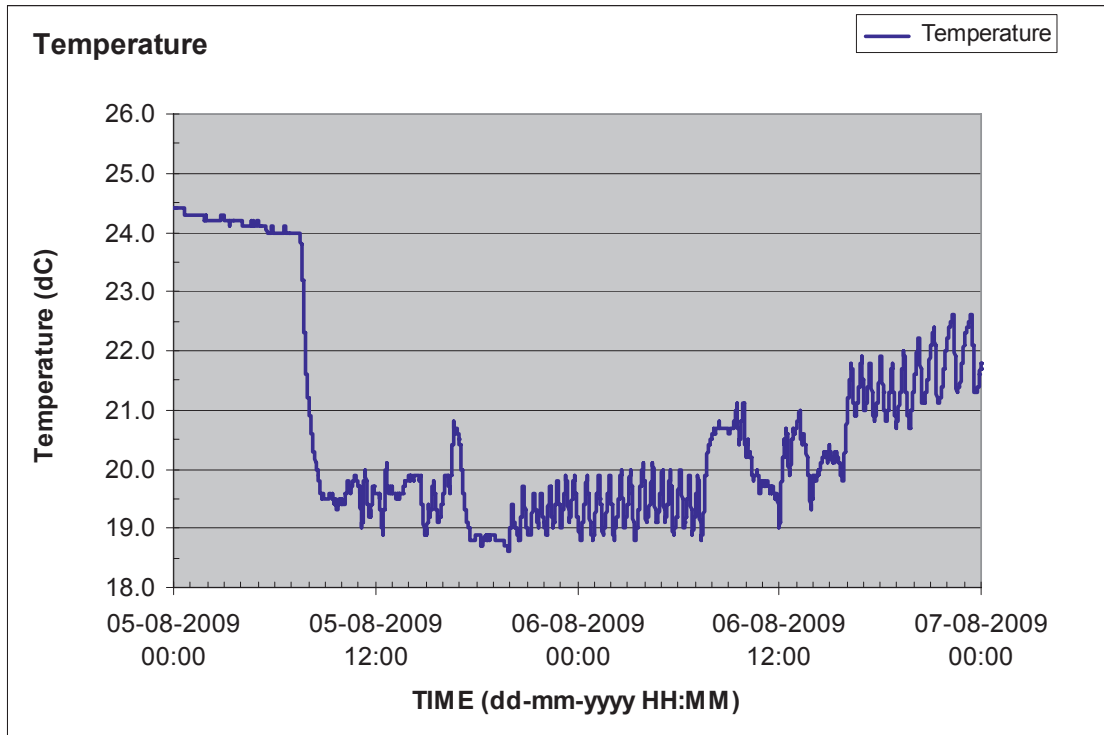
Fig. 4 Measured temperature during the test period

The following graph presents the measured values of temperature.

The temperature and relative humidity was measured during the test period. The following table presents the extreme of temperature and relative humidity:

Date	Temperature		Relative humidity	
	Minimum	Maximum	Minimum	Maximum
August 5 th , 2009	21.7 °C	25.2 °C	30 %	46 %
August 6 th , 2009	22.8 °C	24.6 °C	31 %	39 %

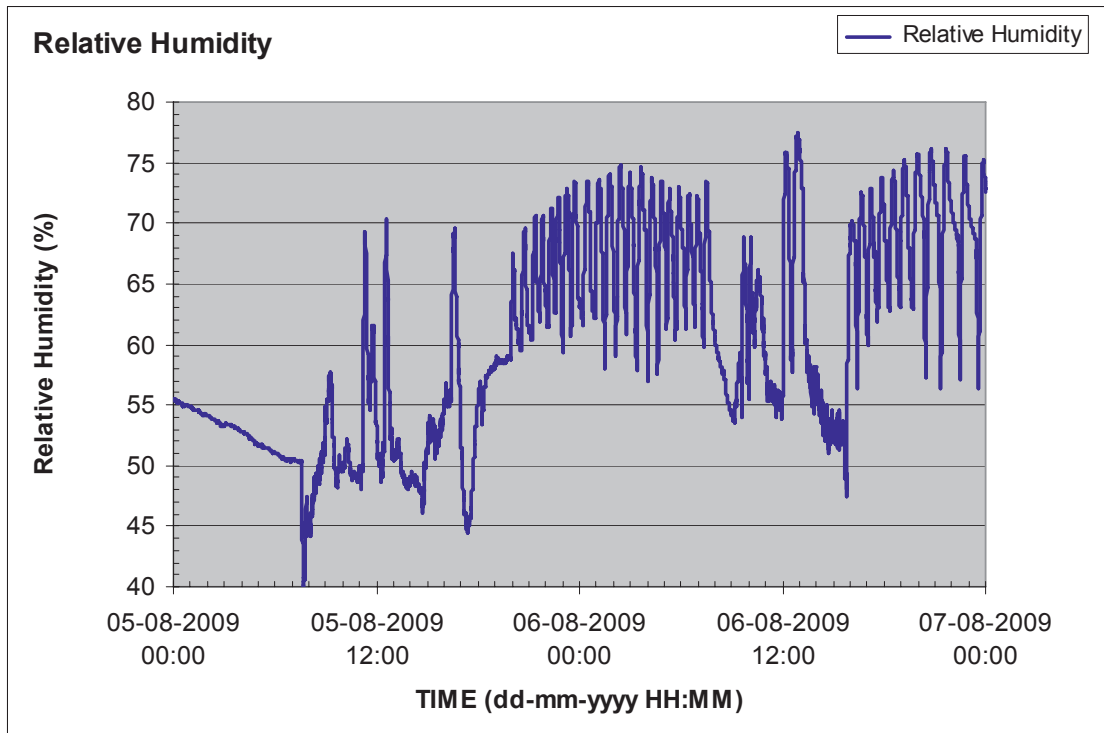
Fig. 5 Measured relative humidity during the test period

The following graph presents the measured value of the relative humidity.

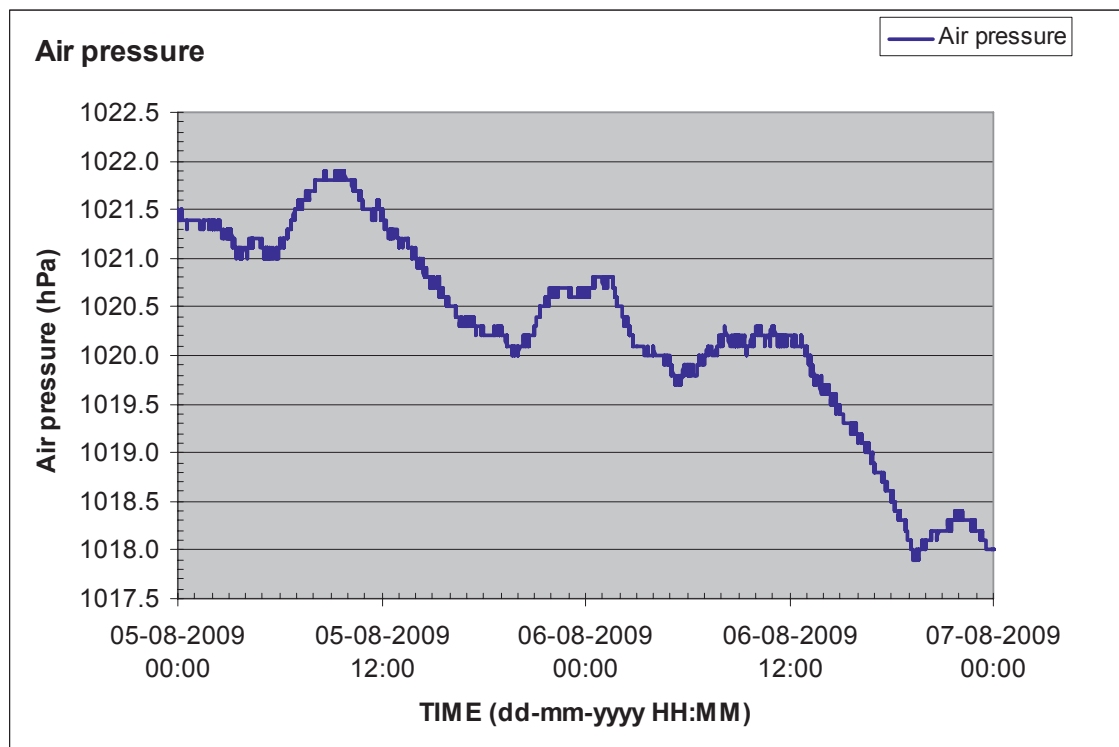
Fig. 6 Measured barometric pressure during the test period

The following graph presents the measured value of the barometric pressure.

Date	Pressure	
	Minimum	Maximum
August 5 th , 2009	1026.6	1028.3
August 6 th , 2009	1025.1	1027.7
