Vibration and Shock tests on a Class TPY Current Transformer Set

NLR-CR-2010-428

Vibration and shock test on the AT01/TPY transformer set

This document contains the description and the results of vibration and Shock tests, performed for ELEQ Steenwijk B.V. on the AT01/TPY transformer set.

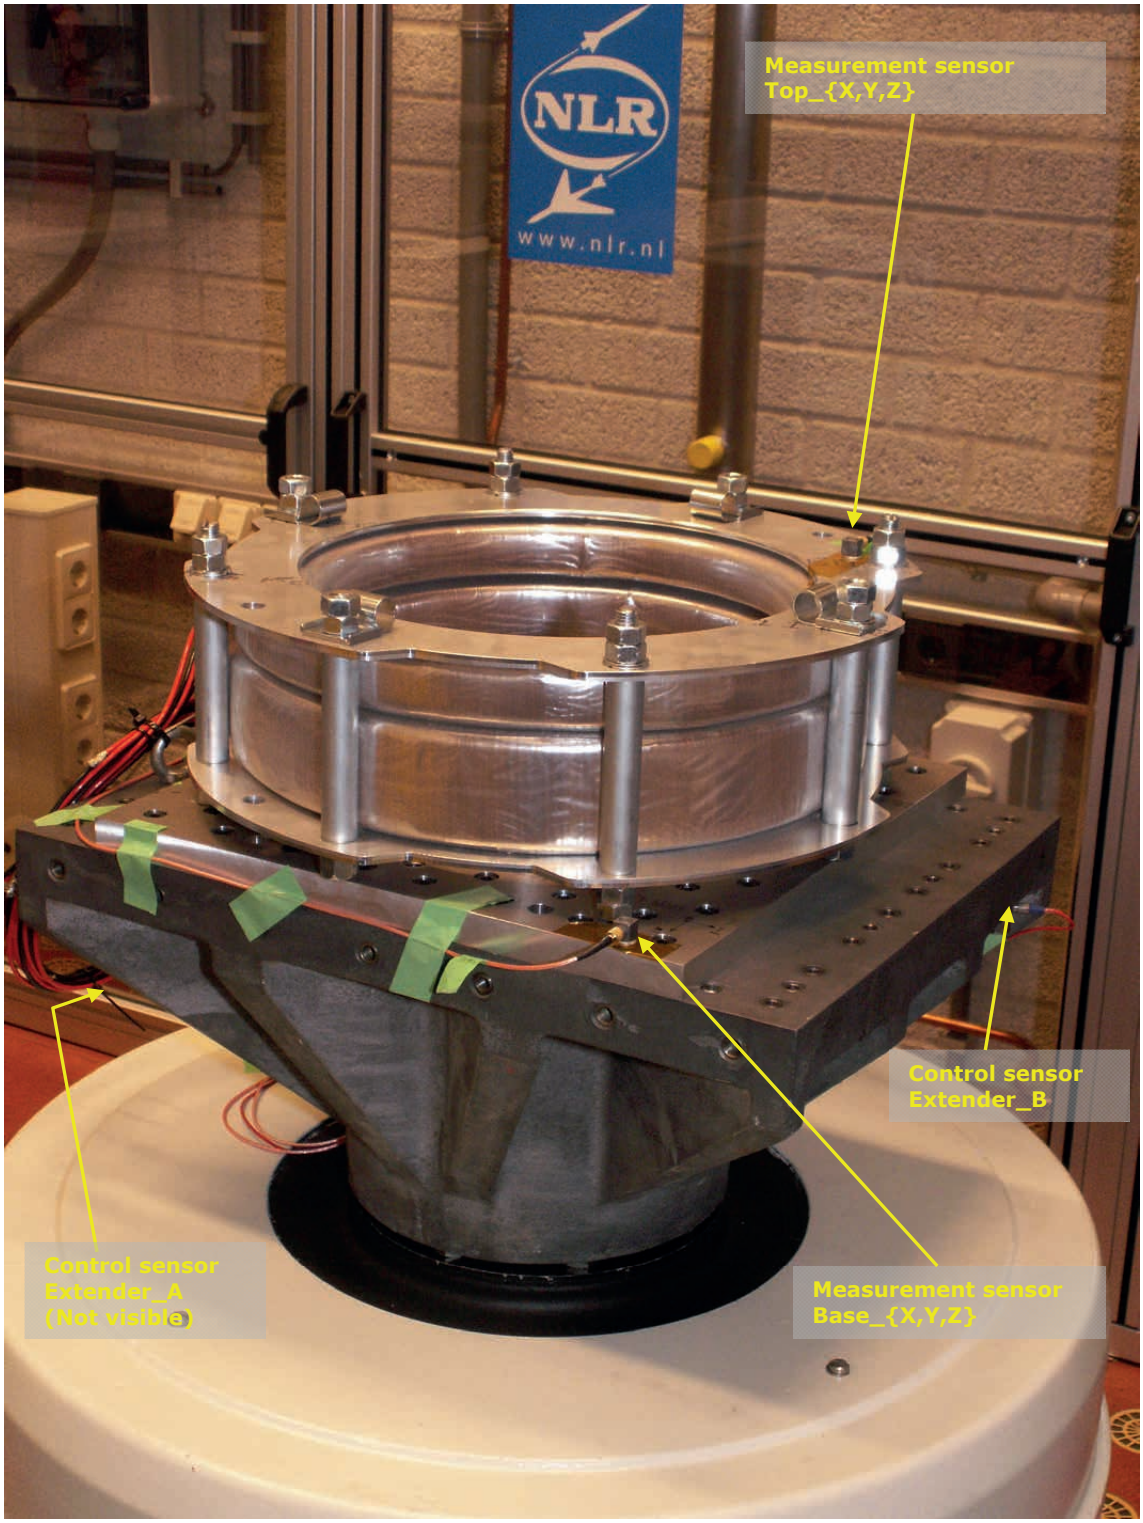
Fig. B.2 Transformer on shaker in Z-direction (vertical)

The test was difficult to control in the Z-direction due to the test object. The transformers are mounted loose in their enclosure.
